Inspection Report
Minerals Regulatory Program
Report Date December 2, 2005

Mine Name: Mill'a Martinique
Operator Name: Martinique Mining

Permit number: S/017/046
Inspection Date: September 13, 2005
Time: 3:30-3:45 PM

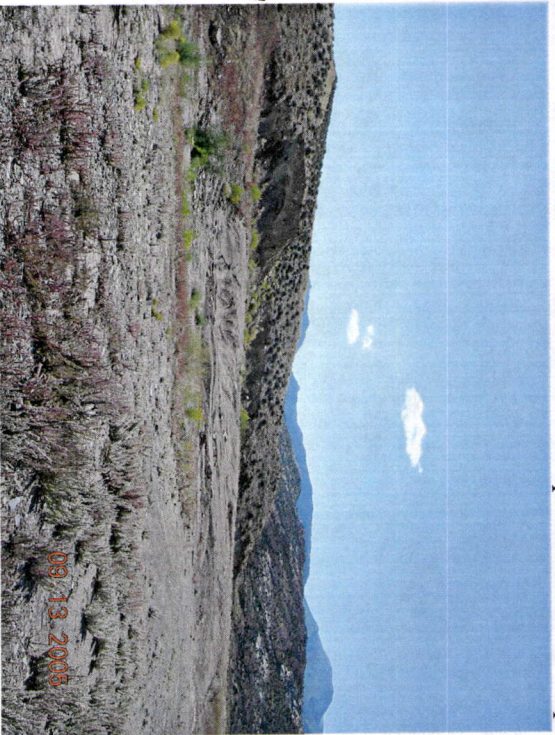
Since this was my first visit to the site, I was not personally familiar with previous conditions, but Mr. Rakow was impressed with how much cleanup work had been done. Pictures from three years ago show several pieces of equipment, old barrels, hoses, PVC pipe, and other items that have now been removed.

Grading has been completed. The site is basically flat.

Photo 1. All of these photos are views of the regraded site.
Note that the equipment and other items have been removed
and that the site blends with surrounding areas.

The site needs to be prepared and seeded this fall. The area should be roughened, and the Division recommends either ripping or using a trackhoe to make pock marks. This helps to harvest water for use by plants.

Immediately after the site is roughened, it should be seeded. There is a letter dated August 24, 2003, where the BLM specifies a seed mix containing galleta, fourwing saltbush, Indian ricegrass, crested wheatgrass, and winterfat.

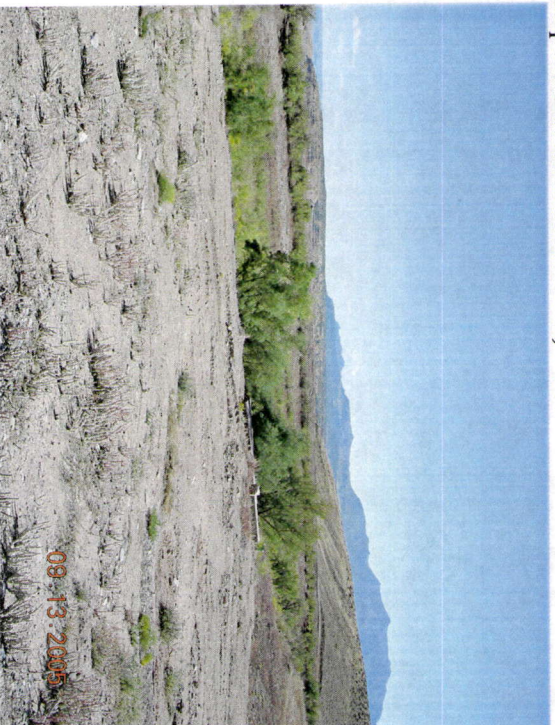
The pond, an irrigation ditch, and a culvert, although apparently used for this operation, have been present for some 30-40 years and are used for grazing.

Photo 3. The pond is just beyond the nearer tall brush.

The ditch, culvert, and pond are used to water cattle, and Mr. Rakow said they should remain for the postmining land use.
